INSPECTION REPORT

SAMPLE PROPERTY

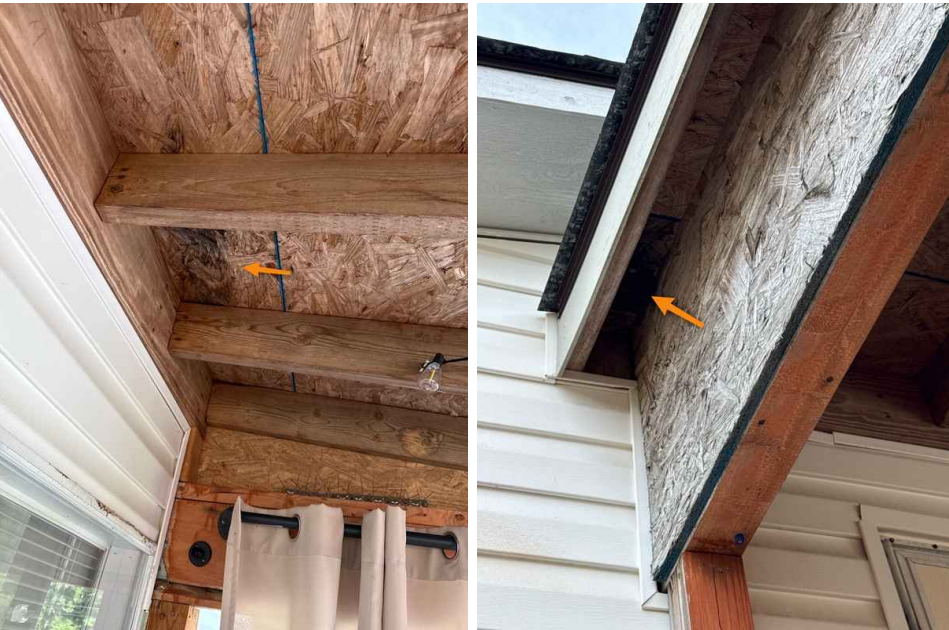
Left Side Of Home

**MOISTURE STAIN FOUND ON OSB ROOF SHEETING**

LEFT SIDE OF HOME: DECK ROOF

Moisture staining was observed on the OSB roof sheathing, indicating possible past or ongoing roof leak. Recommend repair if needed.

Note: roof over this section of deck did appear to be in good condition.

Contact a qualified roofing professional.

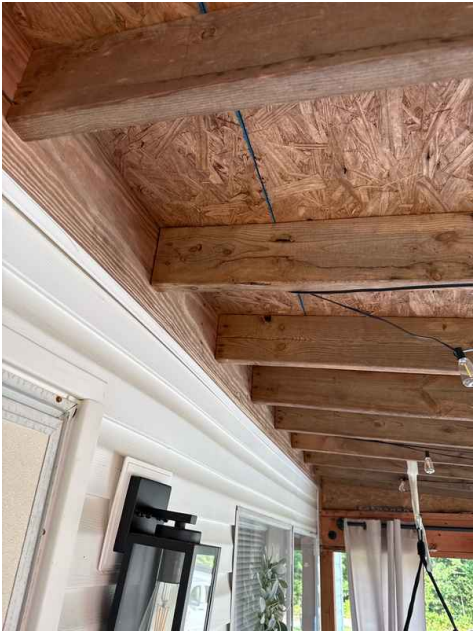
**ROOF FRAMING UNDERCOVER DECK ARE MISSING HANGERS**

LEFT SIDE OF HOME: DECK ROOF FRAMING

Hangers are missing from the roof framing under the covered deck. Recommend installing appropriate hangers and correct the framing as needed.

Contact a qualified general contractor.

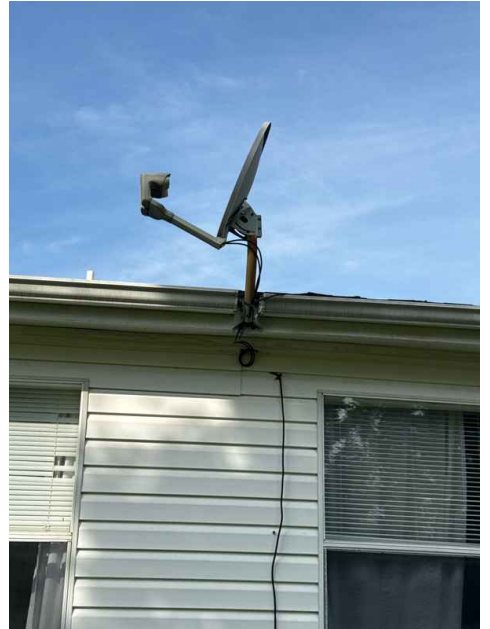
Back Of Home

**GUTTER HAS BEEN SEPARATED TO MAKE ROOM FOR A SATELLITE DISH**

BACK OF HOME

The gutter has been separated to accommodate a satellite dish.  
Some water is likely to pass between the gutters at this location.

Contact a qualified gutter contractor

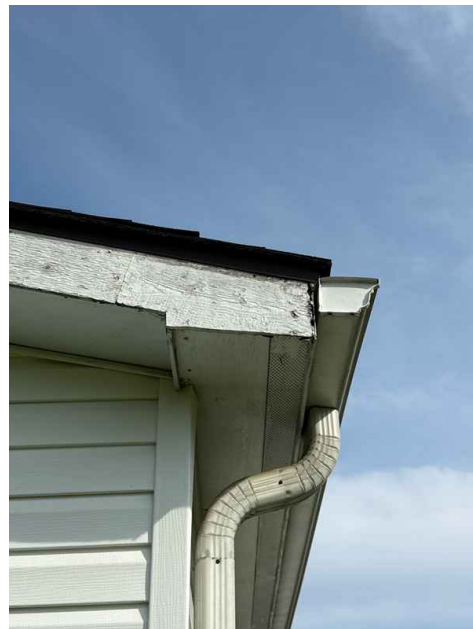
WOOD FASCIA/SOFFITS - ROT FOUND

BACK RIGHT CORNER OF HOME

Wood rot found on fascia/soffits. Recommend replacement of all rotted fascia & soffits as needed.

Contact a qualified handyman.

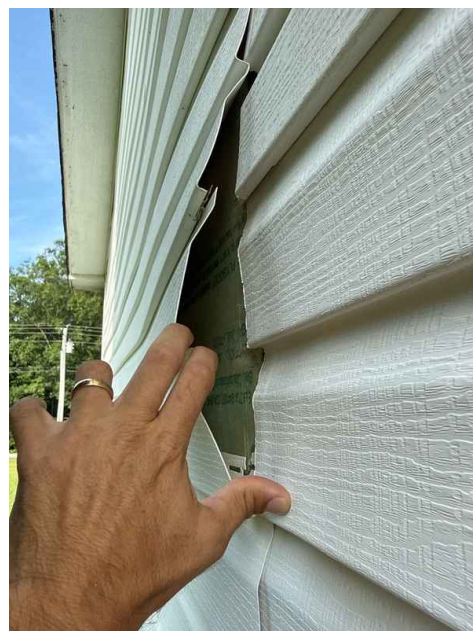
#### **NO HOUSE WRAP PRESENT**

Cannot see any house wrap behind siding. House wrap can reduce energy loss, and help prevent water intrusion.

Note: this is only visible in a small area. House wrap may be present in other areas, but I have no way to know that as I cannot see behind siding.

It is not practical to install house wrap until siding is ready to be replaced. Housewrap was not commonly installed during the build date of this house. Recommend installing house wrap when siding is replaced.

Contact a qualified siding specialist.

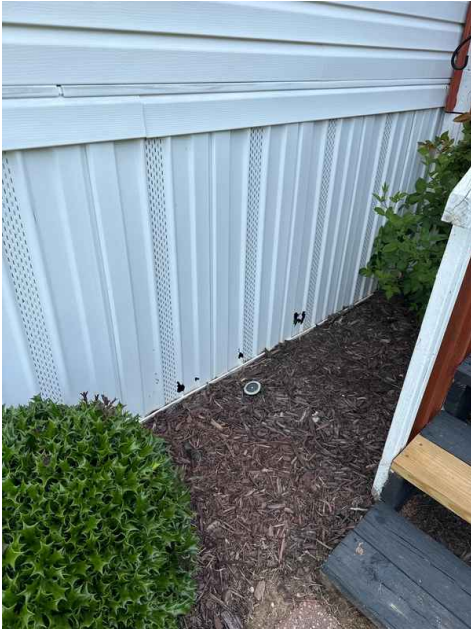
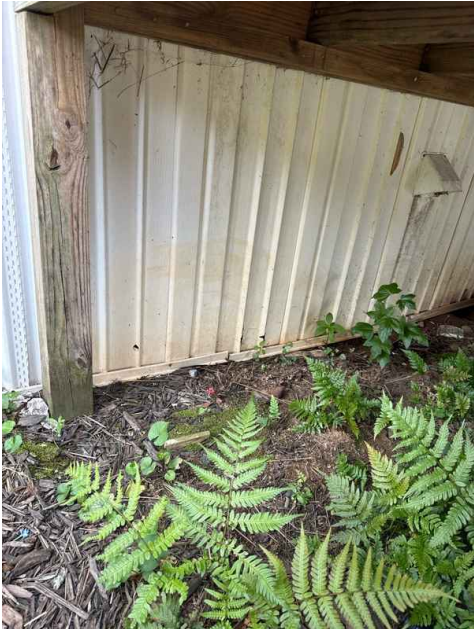
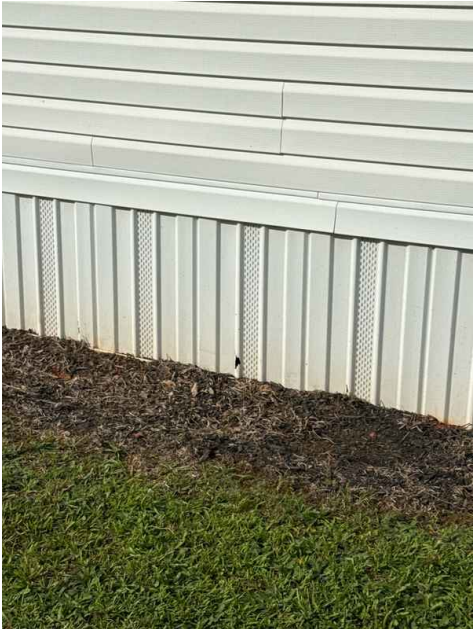
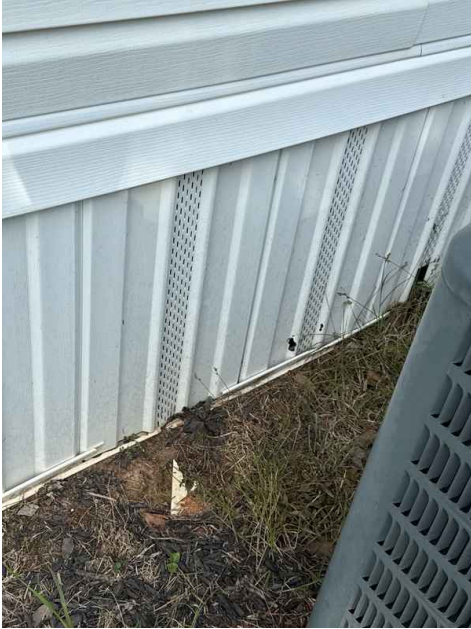
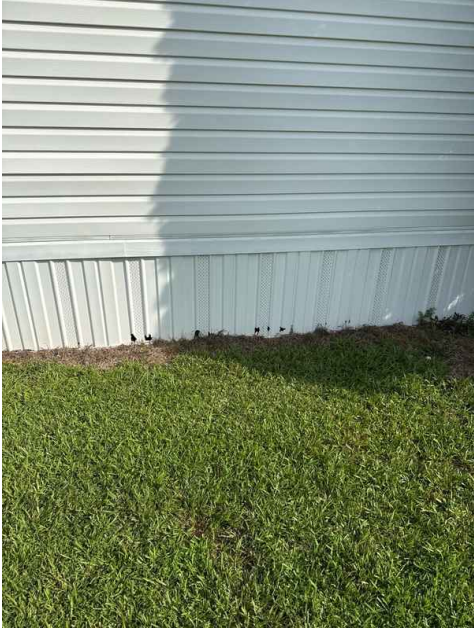
#### **VINYL SKIRTING DAMAGE PRESENT**

MULTIPLE LOCATIONS

Damage is present in the vinyl skirting. Recommend repair or replace the damaged sections of skirting.

Contact a qualified siding specialist.

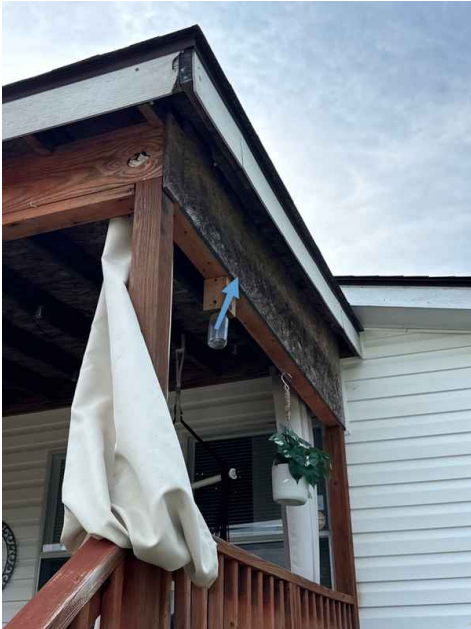
**OSB SIDING IS STAINED**

LEFT SIDE OF HOME

Staining is present on the OSB siding. OSB siding is exposed to outside weather which will degrade the OSB overtime.

Contact a qualified siding specialist.

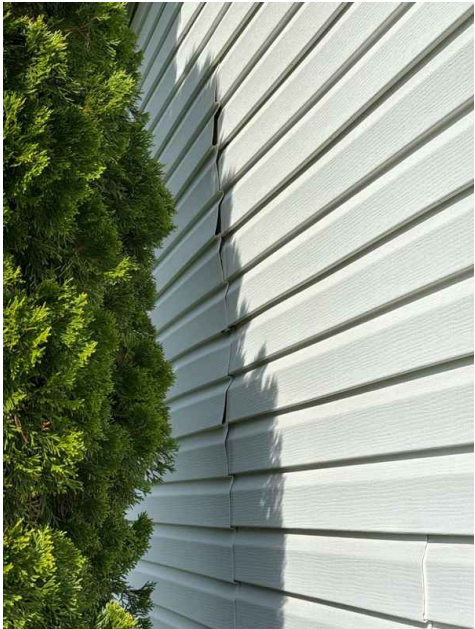
**ABNORMAL INSTALL OF SIDING ON RIGHT SIDE OF HOME**

RIGHT SIDE OF HOME

An abnormal installation of siding was observed on the right side of the home. Siding is not staggered at this location.

I do not know why the section is like that. It is possible that there was an issue in this area that required removal of the siding.

Recommend repair of gaps around siding / poor overlapping.

Recommend asking the homeowner if they are aware of why that had occurred and if any repairs are needed.

If they are unaware then I recommend a siding contractor to evaluate to determine why the siding was cut and installed this way and if any repairs are needed.

Contact a qualified siding specialist.

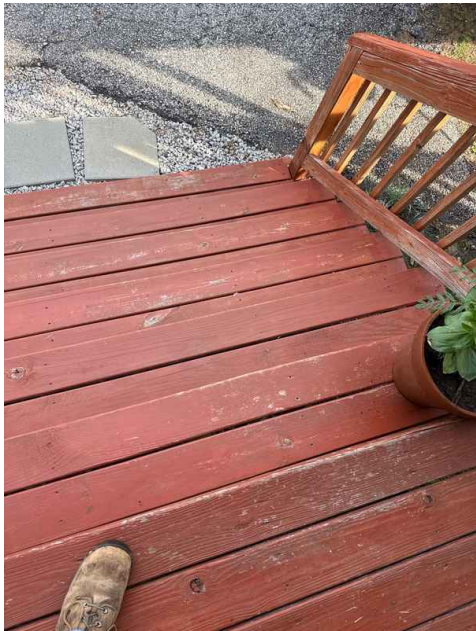
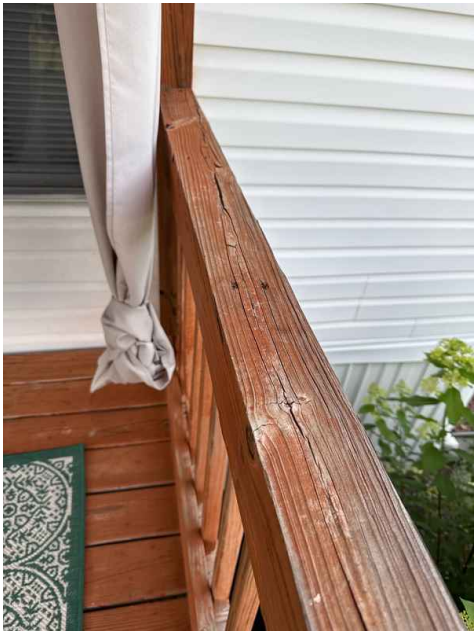
**DECK IS WEATHERED**

BOTH DECKS

Deck is showing signs of weathering. Cracks and rot found on railing and deck. Recommend replacing rotted sections and applying sealant to prolong the life of the deck.

Contact a qualified deck contractor.

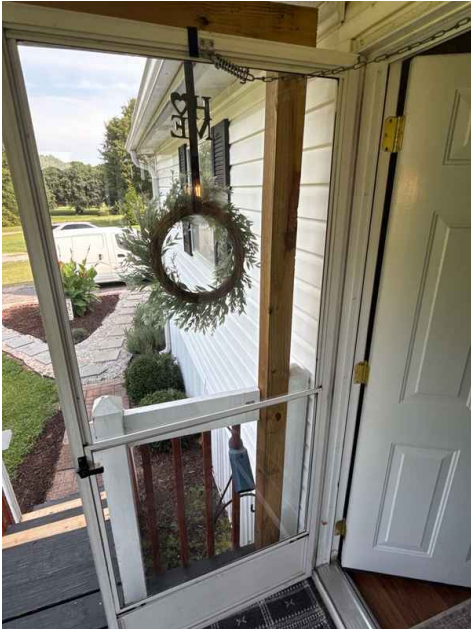
**STORM DOOR - MISSING SELF CLOSER**

Storm door is missing self closer. Recommend installing closer.

Contact a qualified handyman.

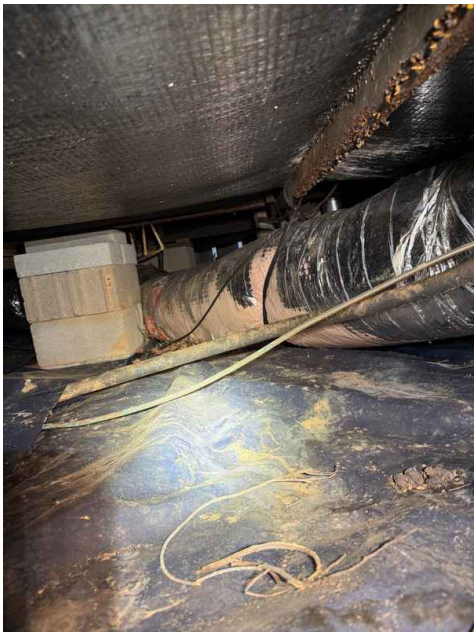
#### 5.3.1 Ductwork DUCT DAMAGED

CRAWLSPACE

Ductwork is damaged. Duct is discolored indicating condensation occurring between the insulation and the duct. Insulation is torn as well. Repair recommended.

Contact a qualified HVAC professional.

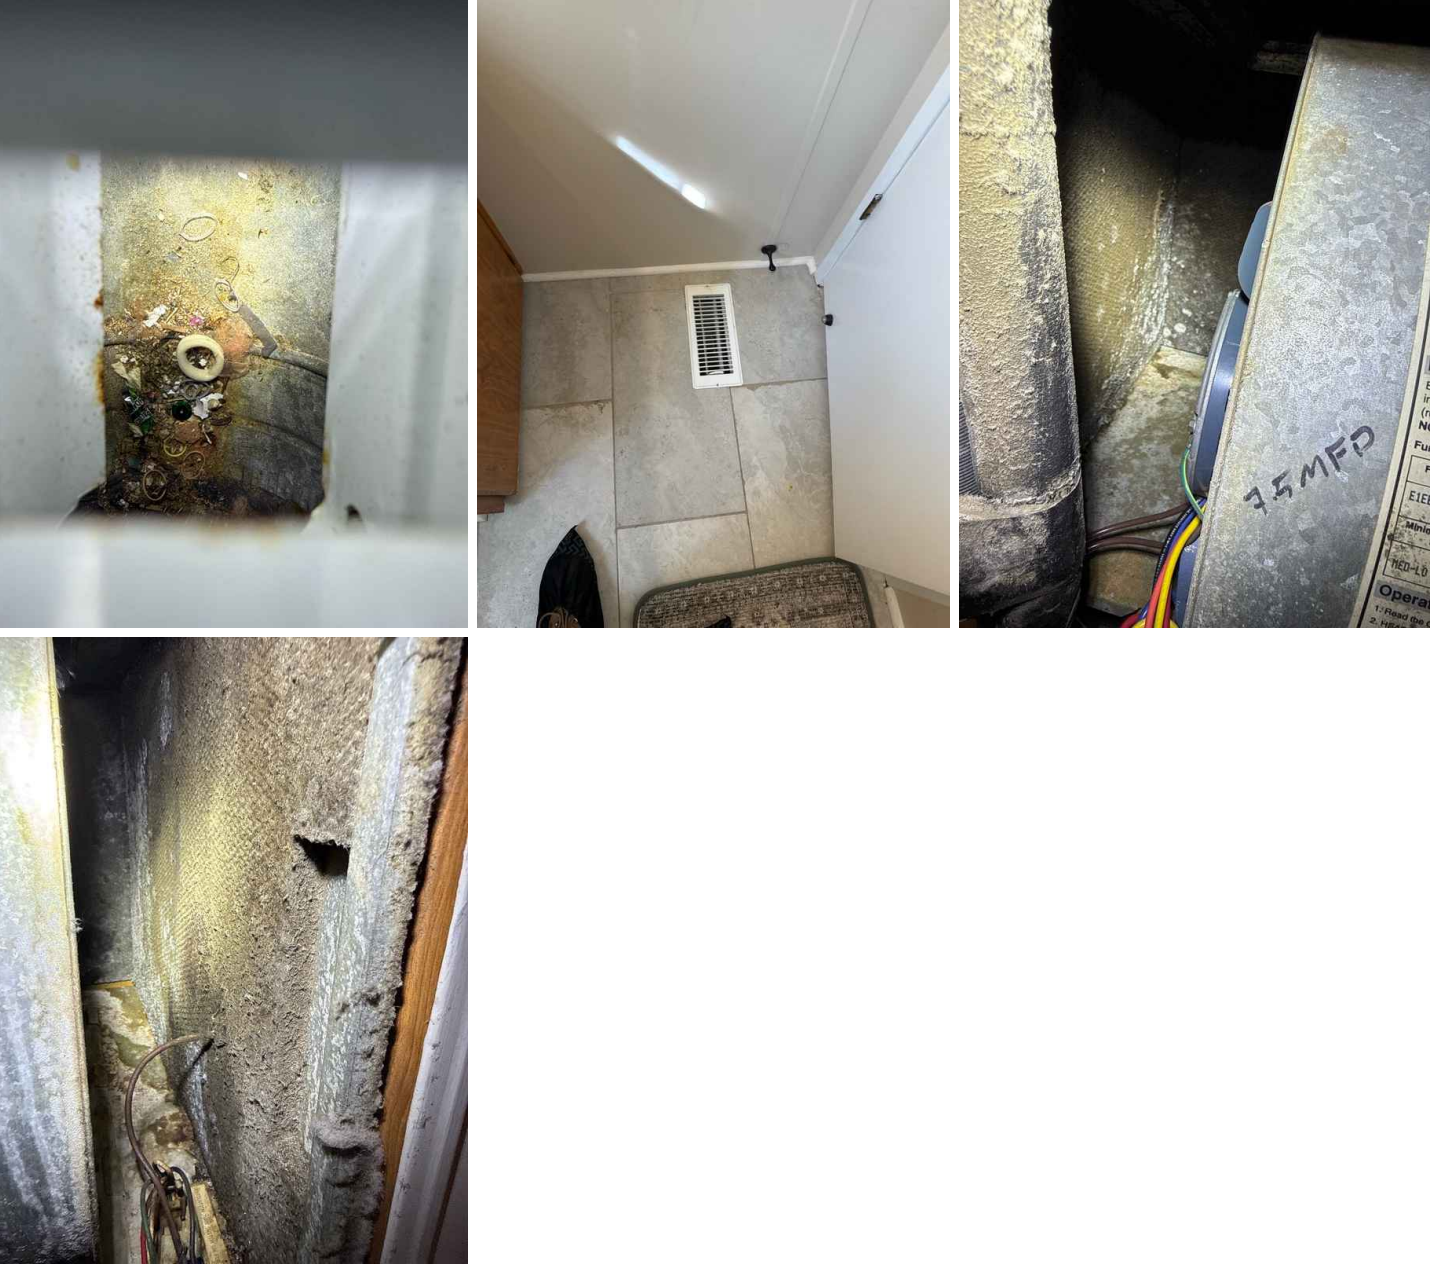
DUCTS ARE DIRTY

ALL DUCTS

Ducts are dirty, floor vents collect debris easily. Recommend cleaning.

Recommendation  
Contact a qualified professional.

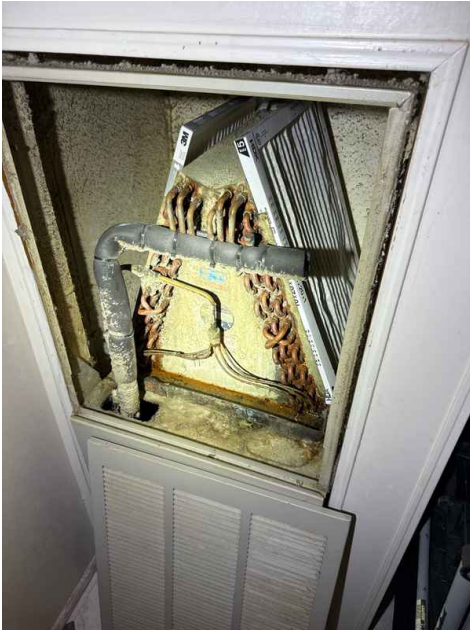
#### RECOMMEND SERVICING HVAC SYSTEM

Recommend HVAC tech service the HVAC system, clean evaporator coil and evaluate further to determine its reliability.

Contact a qualified HVAC professional.

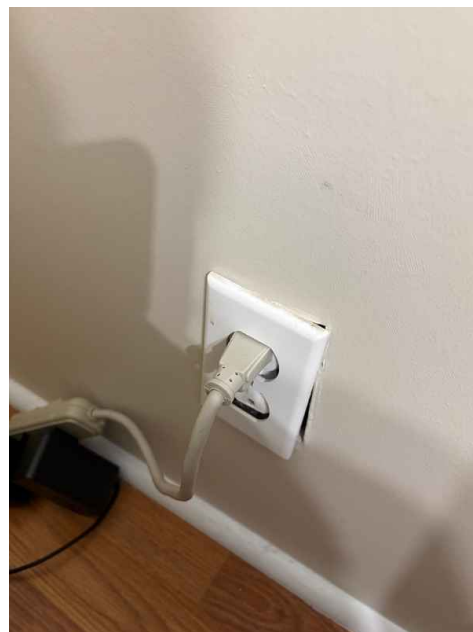
##### **OUTLET COVER - LOOSE**

An electrical outlet cover is loose. Recommend securing or replace the outlet cover.

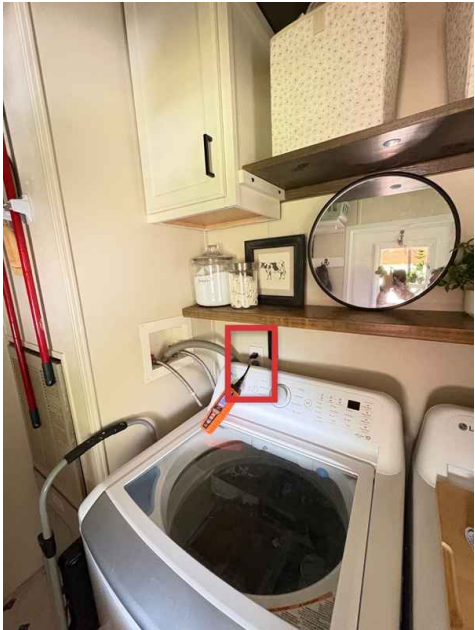
##### **GFCI PROTECTION MISSING IN AREAS**

GFCI protection is missing in some areas. GFCI outlets should be installed in all areas that could be exposed to water. (Outside, Kitchen, Bathrooms, Laundry room & Garage).

Recommend installing GFCI protection.

Recommendation  
Contact a qualified electrical contractor.

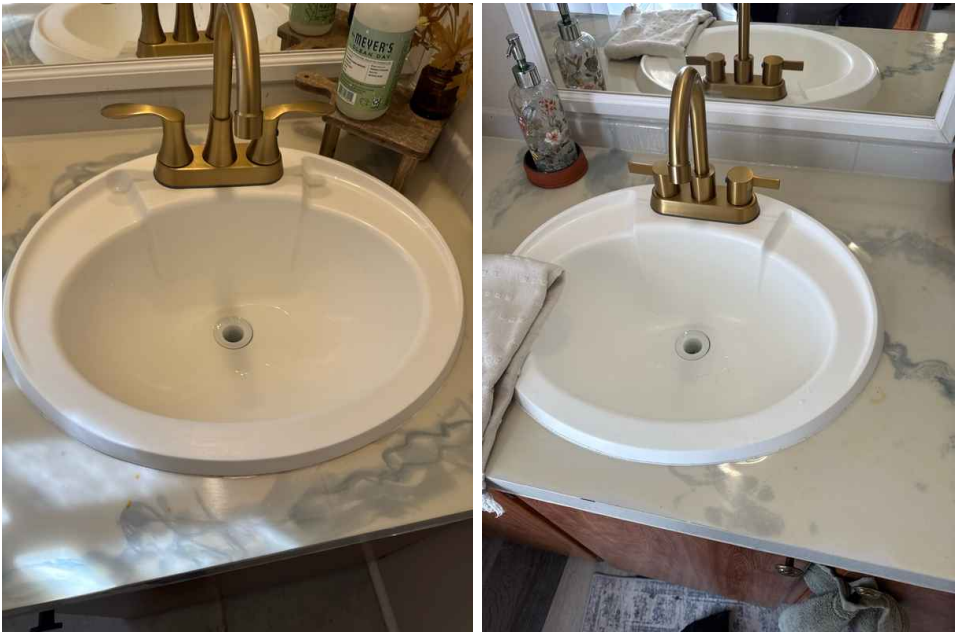
Hallway bathroom

STOPPER - MISSING

Missing stopper. Recommend replacement.

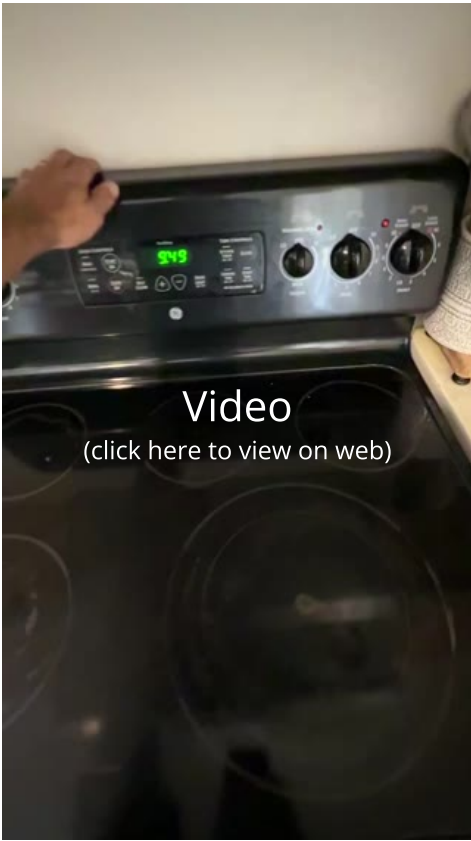
### OVEN - MISSING ANTI-TIP KITCHEN

Anti-tip bracket not present on the oven. This could potentially be a safety hazard for children if they attempt to climb on the oven since it could fall on them. An anti-tip bracket will prevent that from occurring.

Contact a qualified handyman.

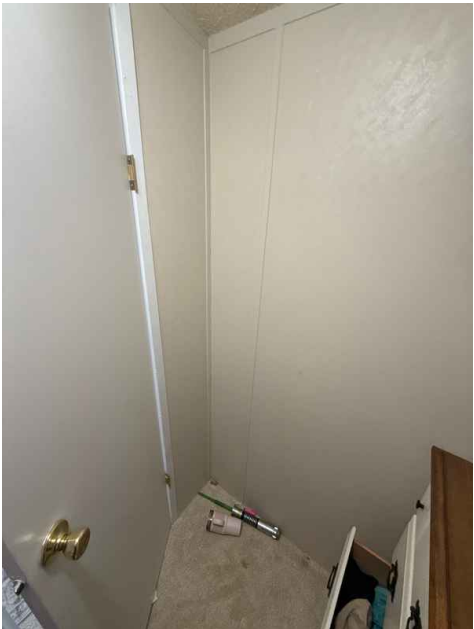
Bedroom Closet

#### DOOR - MISSING DOORSTOP

Door is missing doorstop. Recommend installing stop to prevent damage to drywall and door.

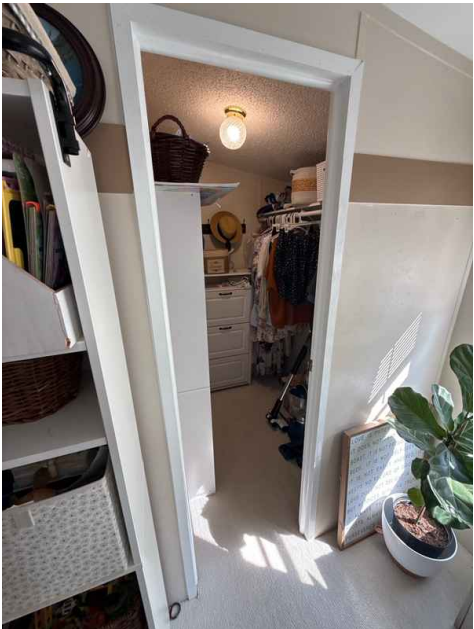
Master Bedroom

#### DOOR IS MISSING

A door is missing. Recommend installing a properly fitted replacement door.

Contact a qualified handyman.

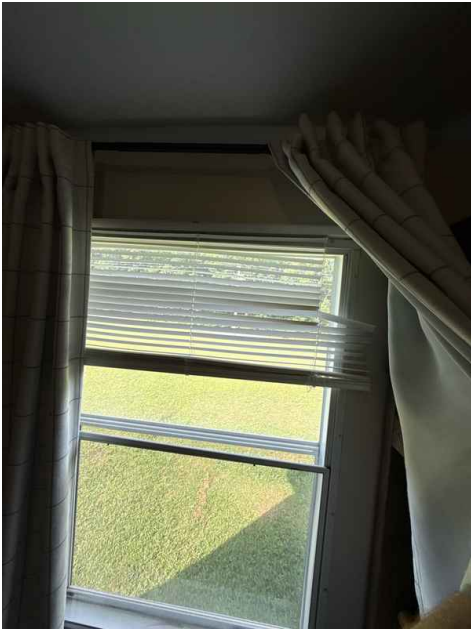
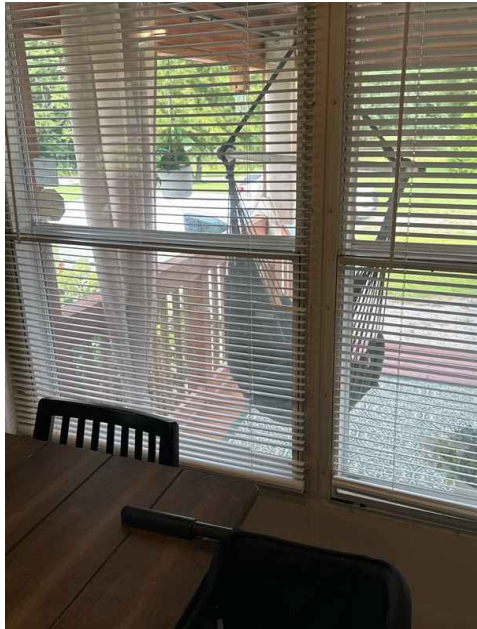
**BLINDS - DAMAGED**

Blind is damaged. Recommend replacing blinds

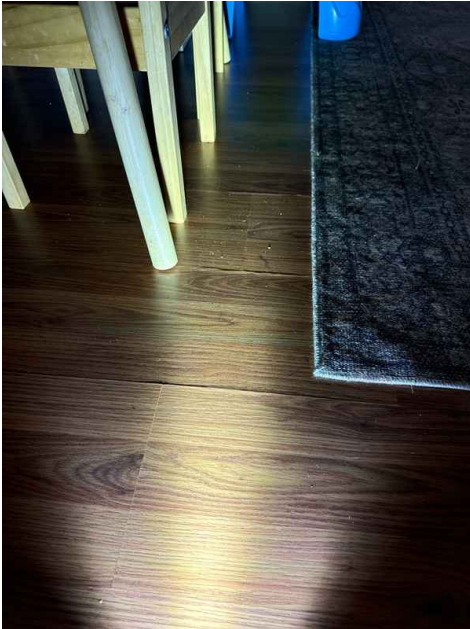
Swollen laminate flooring is present. It typically occurs from moisture, such as from leaks or using excessive water while mopping. Damage appears to be minor in my opinion.

Recommend a flooring contractor to repair.
